Gas Everywhere!

It was 2:45 am on 7 May 2020 in the Indian city of Vishakhapatnam (Vizag for short). Amid the sleeping residential areas was a factory, largely shut due to the Covid-19 lockdown. The scaled down night shift staff were there for security and to monitor basic safety issues. No one dreamt that just a few minutes later all hell would break loose. “Gas, Gas!” shouted an alert night shift worker when he smelt and saw the fog drift from tank M6 at the LG Polymers factory. Within minutes the whole factory premises and the surrounding residential areas were engulfed in foul smelling vapours. The styrene gas leak accident at the factory resulted in 11 deaths and more than 1,000 sick after exposure to the gas.

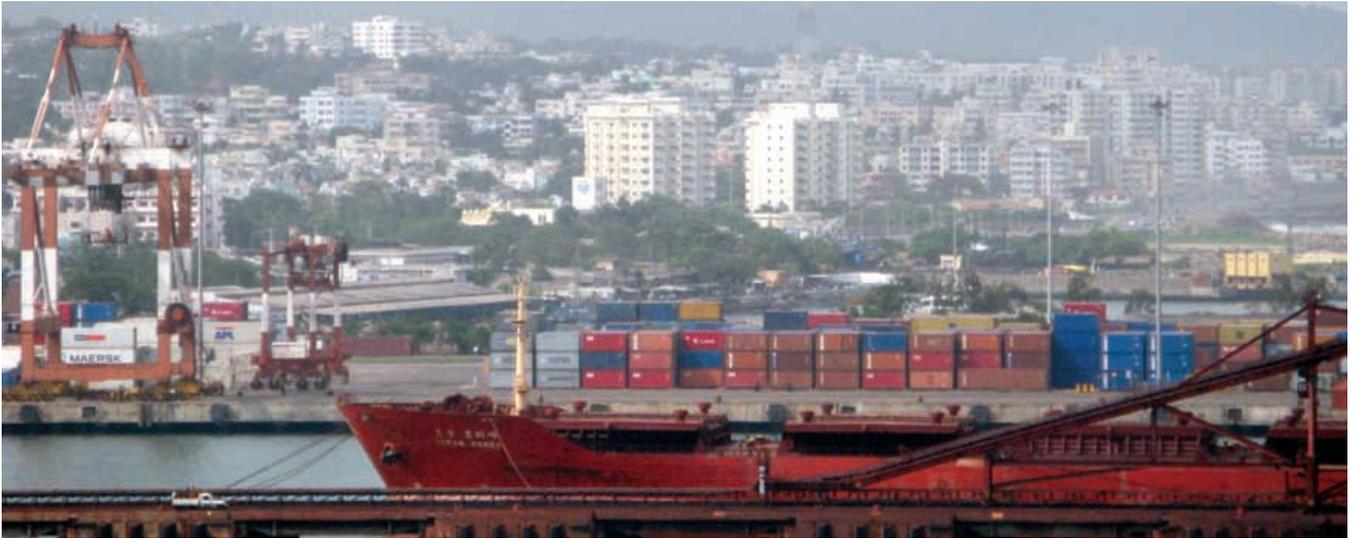
The syrene release at Vizag was entirely preventable and lives could have been saved ©Creative Commons
